Saba Metallurgical & Plant Engineering Services, LLC

Shell Overheating Distortion Fitness-for-Service (Finite Element Analysis, 3D Laser Scanning, ASME FFS-1)

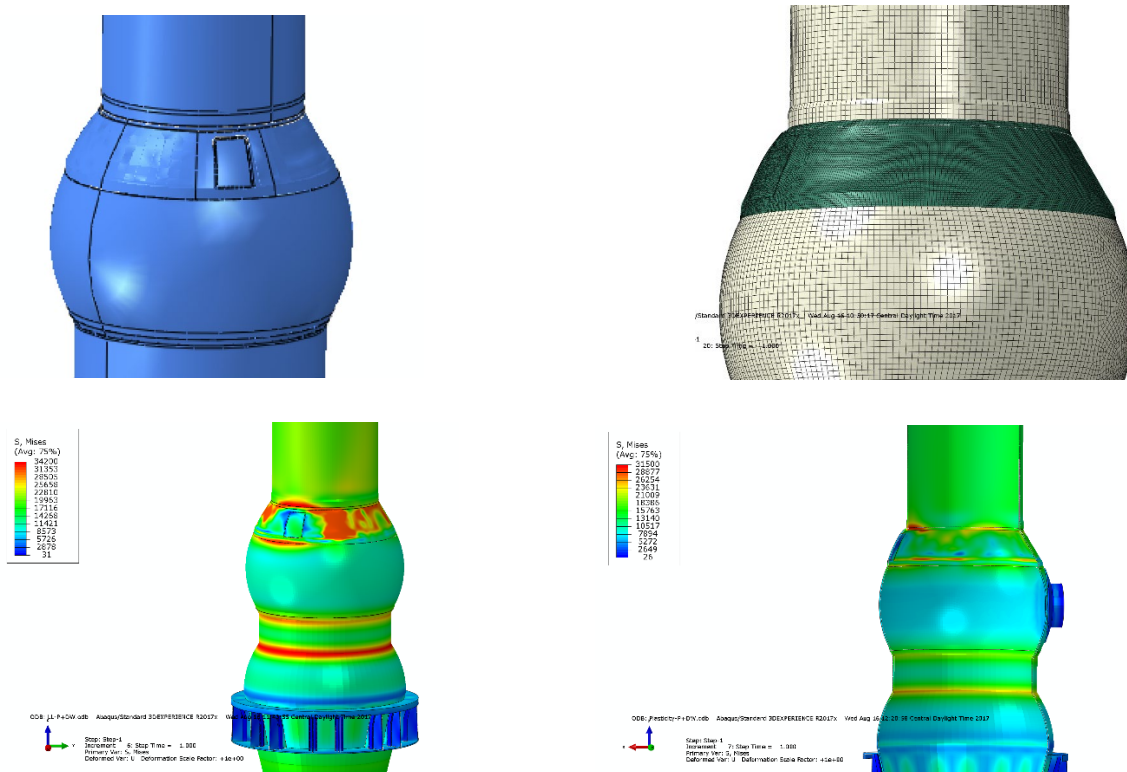
FEA Results: Pertinent images of this fitness-for-service study are shown below:
