## Saba Metallurgical & Plant Engineering Services, LLC

### Materials Projects

**Projects Brief Details:** Saba Metallurgical provides services assisting in material selection and troubleshooting. The below list details some very brief information on a select few of these projects.

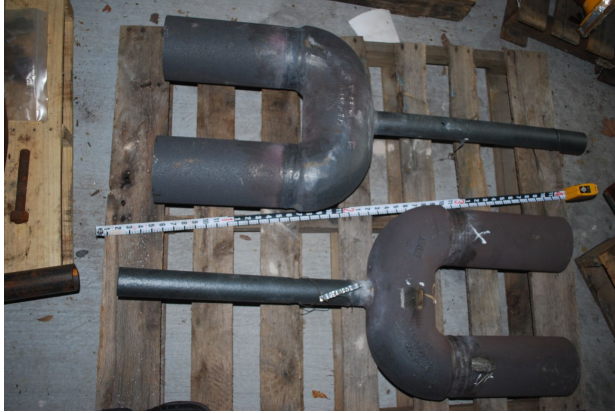
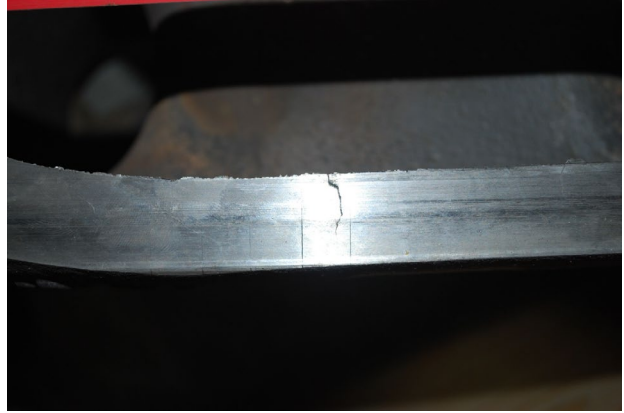
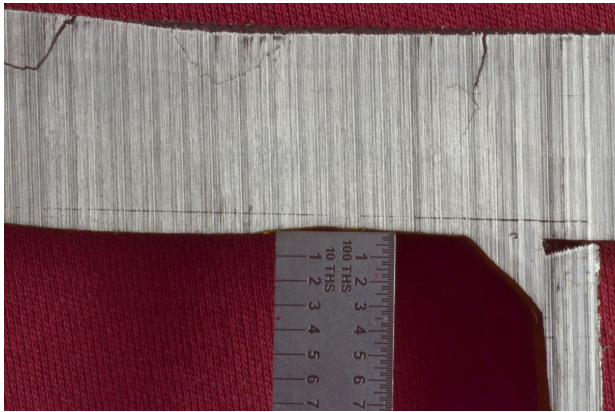
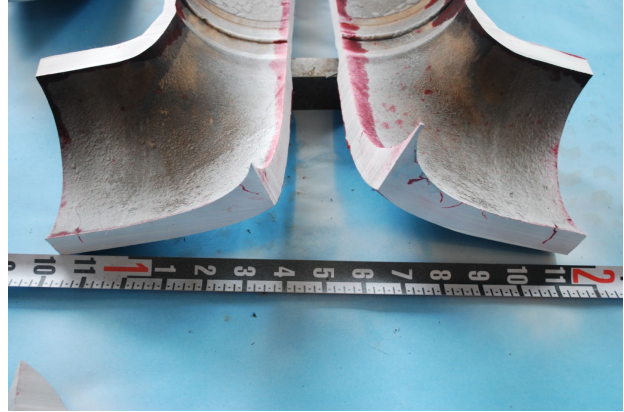
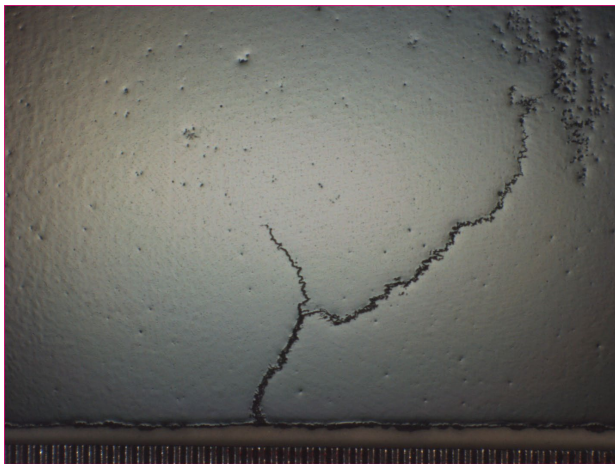
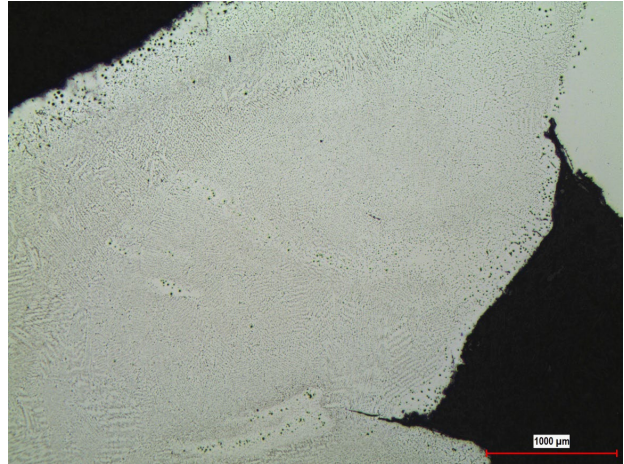
6. Reformer furnace review produced prediction that first bends would be experiencing ID cracking due to thermal shock/impact from the cool-down nitrogen purge. Upon removal of u-bends for inspection, up to 90% through wall cracking was observed. Identification of this damage from this requested inspection helped prevent a destructive furnace fire and then led to a revision of the operating procedure.

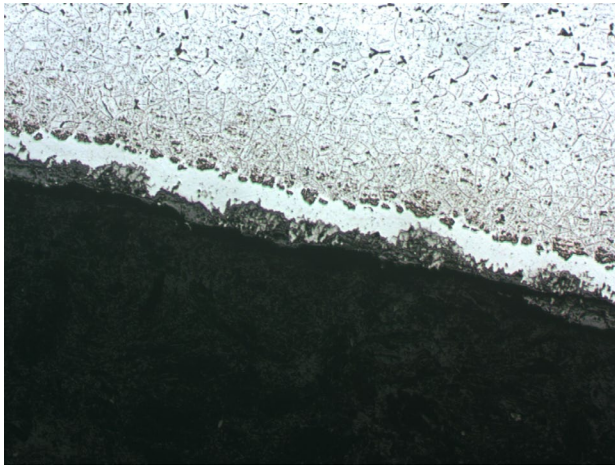
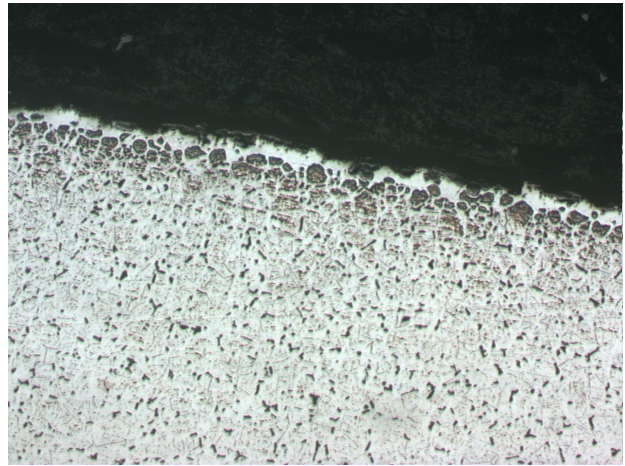
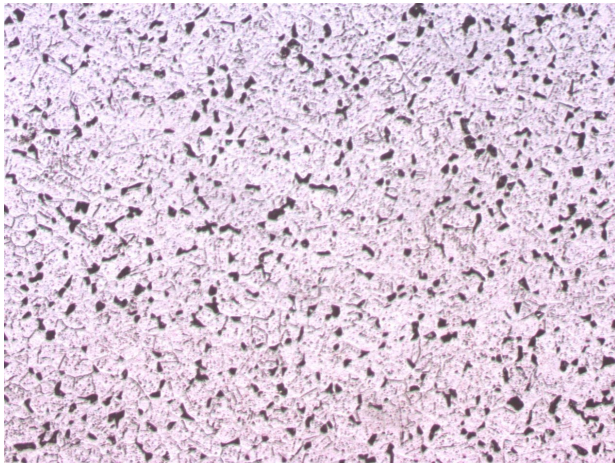
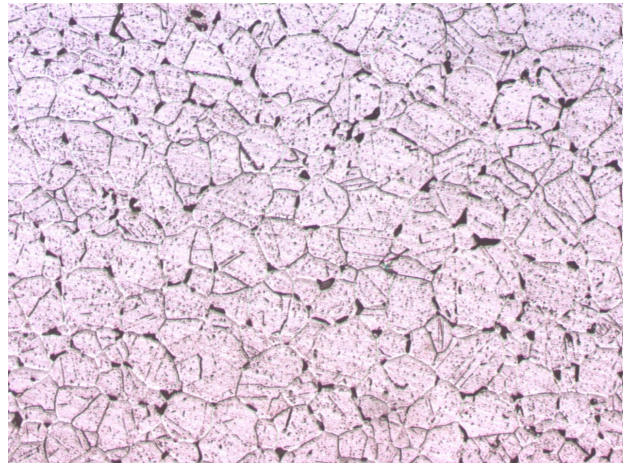
7. A multi-million-dollar heat exchanger was deemed to be scrapped due to highly excessive thinning (6-8 mils remaining thickness) of the tubes. Eddy current was used to make this determination. It was advised to the client that part of the tube bundle operated where the microstructure changed to several other types of phases (Laves, Chi, Sigma etc.) and carbide precipitation. This microstructure change caused the electromagnetic properties to change for the tube material. As calibration was performed on new material, the eddy current was not calibrated properly, leading to the grossly under-identifying of the actual tube wall thickness.
