New High Temperature Heat Exchanger Bridge Impact Damage Fitness-for-Service (Finite Element Analysis, Explicit Analysis, Forming, Impact, Cyclic-Creep)

Project Description: A new high temperature heat exchanger impacted a bridge during delivery to the site. The impact occurred on the top shell expansion joint. An FEA model was created of the heat exchanger, with two initial analyses evaluating the forming stresses of the EJ and the impact with the bridge, using the explicit solver. The impact damage was replicated by iteratively comparing the dent size and depth to provided 3D laser scanning data. Strain-rate hardening material properties were used. Forming and impact stresses/strains are carried over to a cyclic-creep cyclic-by-cycle analysis model by use of an initial state function. Both damaged and undamaged versions of the heat exchanger were evaluated. It was determined that after a couple cycles, the damaged area goes into elastic shakedown, and the ultimate cycle life, based on both creep and plasticity, was still within original design specifications. Adjacent welds were only exposed to elastic stresses; however, it was recommended to perform both surface and volumetric

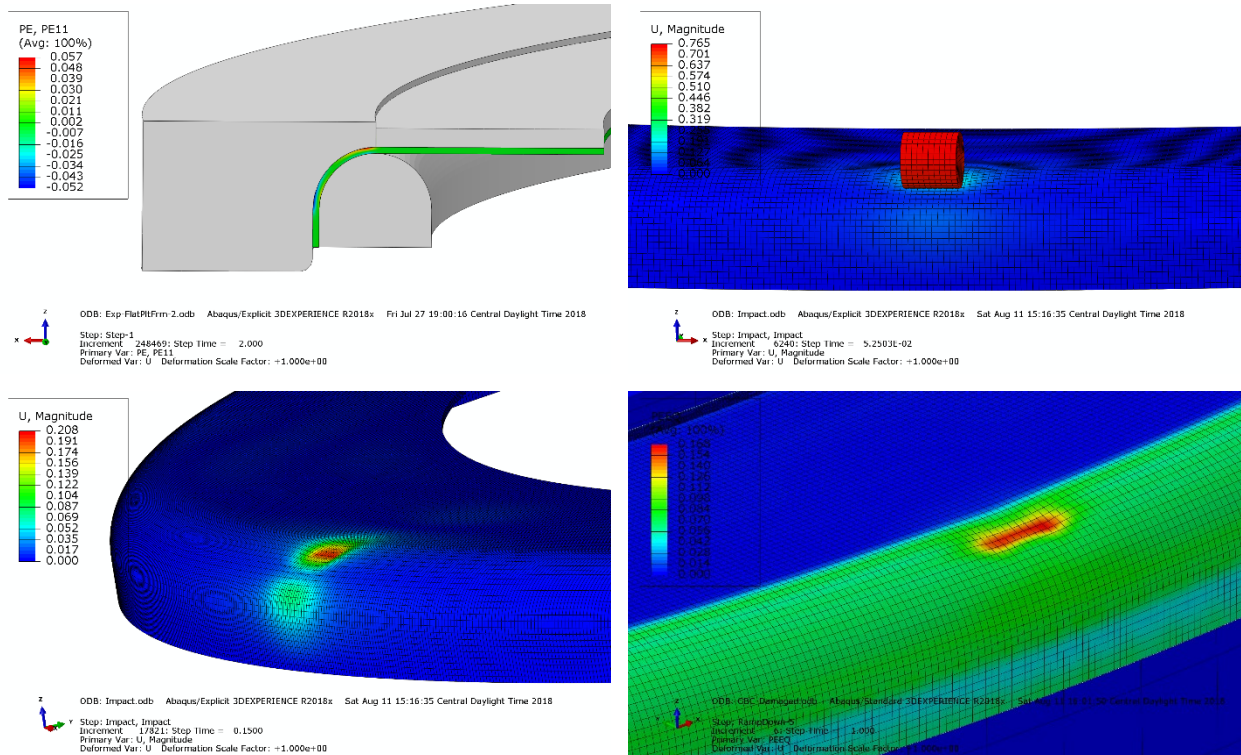
FEA Results: Pertinent images or this fitness-for-service study are shown below:
