High Temperature Heat Exchanger – Low Cycle Fatigue Assessment Post Fabrication Design Analysis (Finite Element Analysis, ASME Section VIII Div. 2, ASME FFS-1)

Project Description: A high temperature heat exchanger with an elaborate array of internal refractory, ferrules, and shell-side insulation was evaluated for low cycle fatigue (LCF). Issues with LCF were observed with a sister exchanger and a detailed fatigue assessment had not been conducted during the design stage for either exchangers. Thus, this exchanger was evaluated post-fabrication, placing it into the realm of fitness-for-service (FFS), with the desire to understand the allowable number of cycles. A highly detailed FEA model was created, allowing for proper capture of the distributed temperature profile. Then, these cycles between ambient and steady-state were evaluated using both ASME Section VIII Div. 2 Twice Yield and Cycle-by-Cycle analyses, both elastic-plastic non-linear methods. The end result was the client receiving the allowable number of cycles and the component or components most likely to fail first.

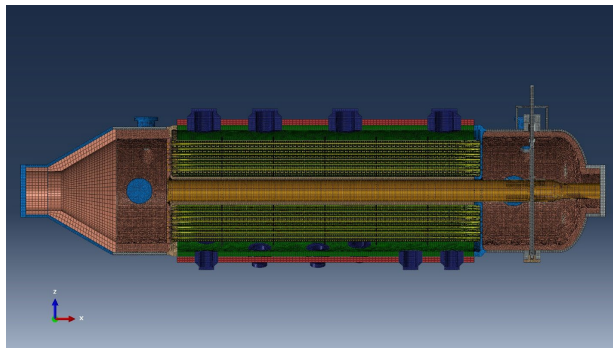
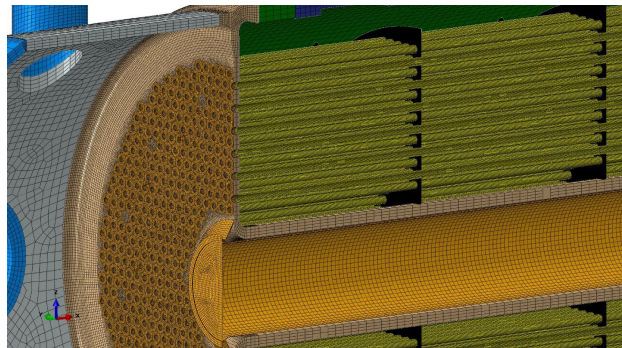
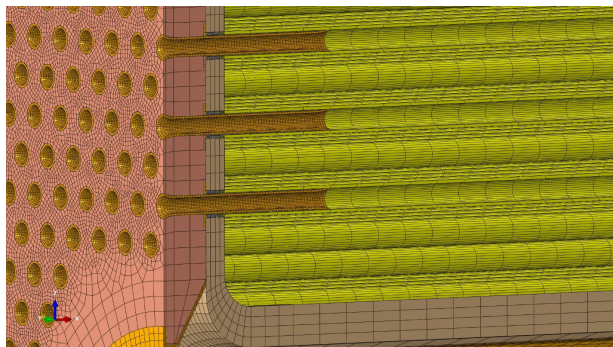
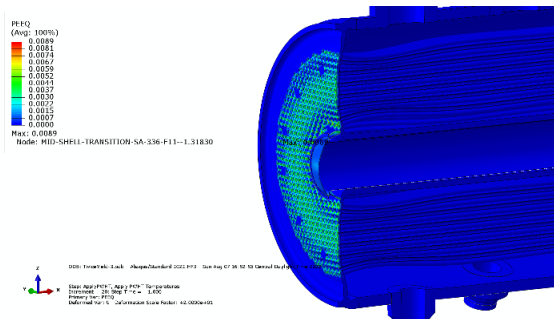
FEA Results: Pertinent images or this fitness-for-service study are shown below:
